**THE EFFECTS OF PLUGGING A DEEP ARTESIAN WELL ON THE
CONCENTRATION OF CHLORIDE IN WATER IN THE WATER
TABLE AQUIFER AT HIGHLAND ESTATES, LEE COUNTY, FLORIDA**

By
D. H. Boggess
Open-File Report
73003

Prepared by
U.S. GEOLOGICAL SURVEY
in cooperation with
FLORIDA DEPARTMENT OF NATURAL RESOURCES
BUREAU OF GEOLOGY
and the
COUNTY COMMISSIONERS OF LEE COUNTY

1973

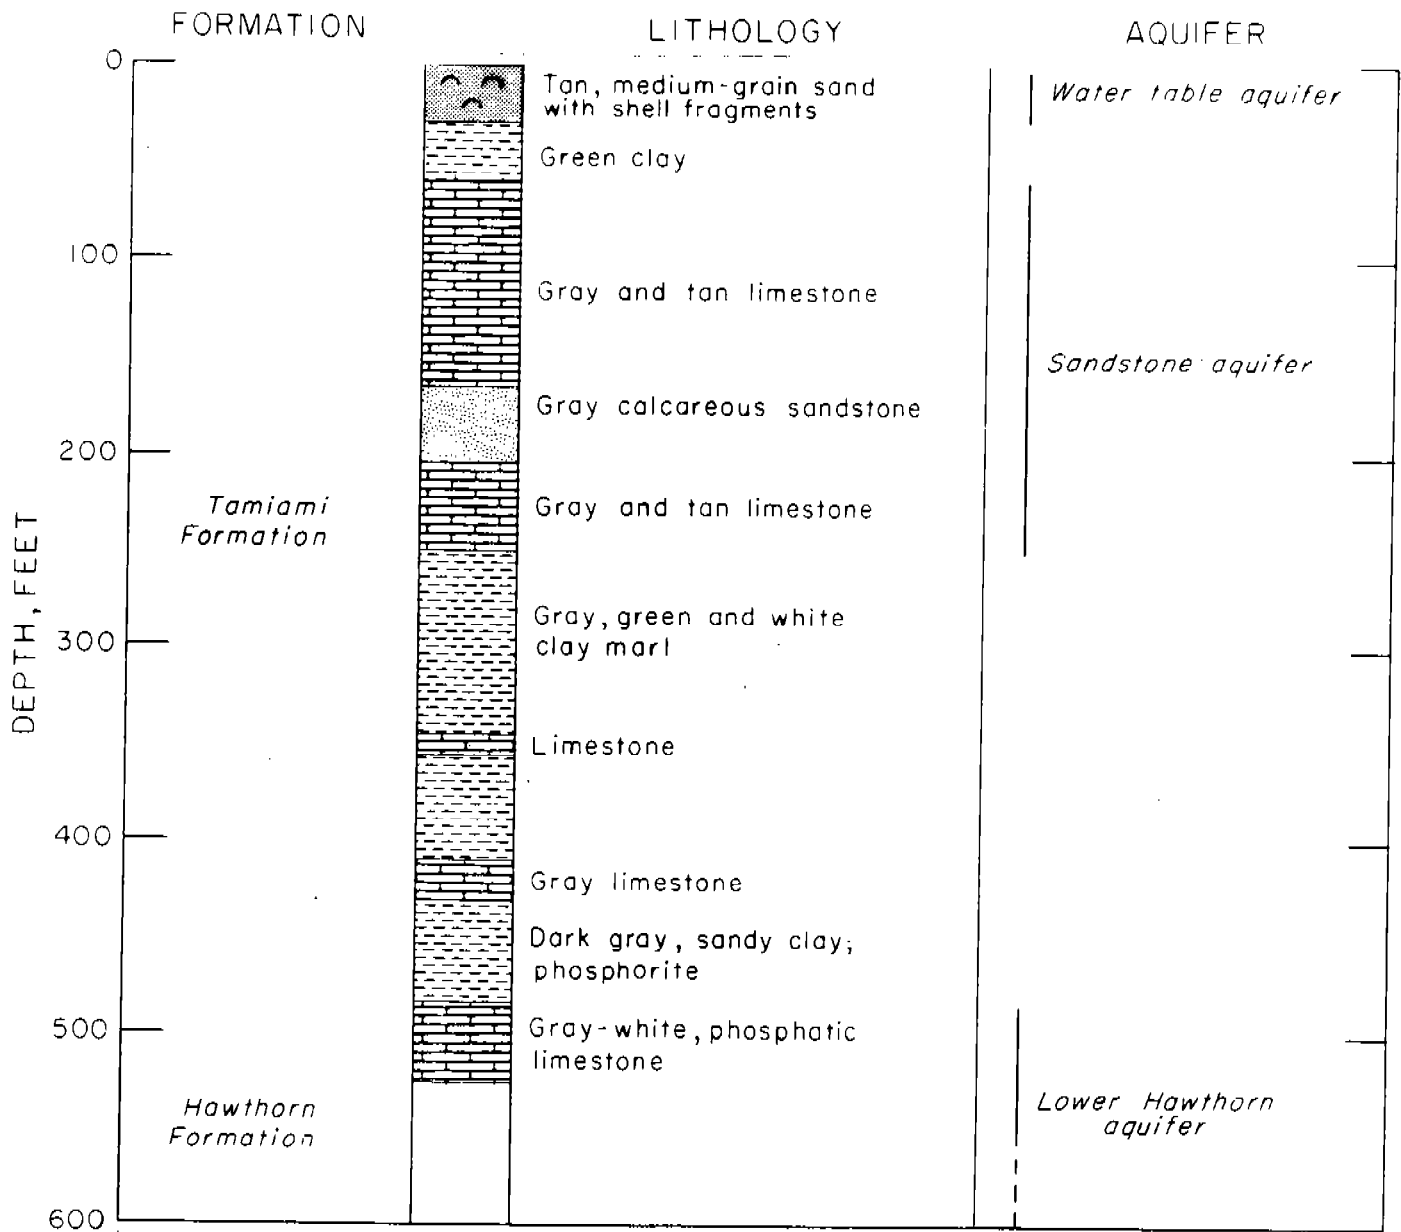
Figure 2.--Composite log of formations, lithology, and aquifers underlying Highland Estates.

The uppermost water-bearing unit that underlies Highland Estates is called the water-table aquifer. It consists of tan colored medium sand and some shell fragments (fig. 2). It extends from the land surface to a depth of about 30 feet. The aquifer is recharged directly by rainfall. The water table fluctuates from 2 to 6 feet below the land surface (6-10 feet above sea level) during the rainy season and from 9 to 10 feet (2-3 feet above sea level) during the dry season. The chloride concentration in water from the aquifer generally ranges from 20 to 40 mg/l (milligrams per liter).

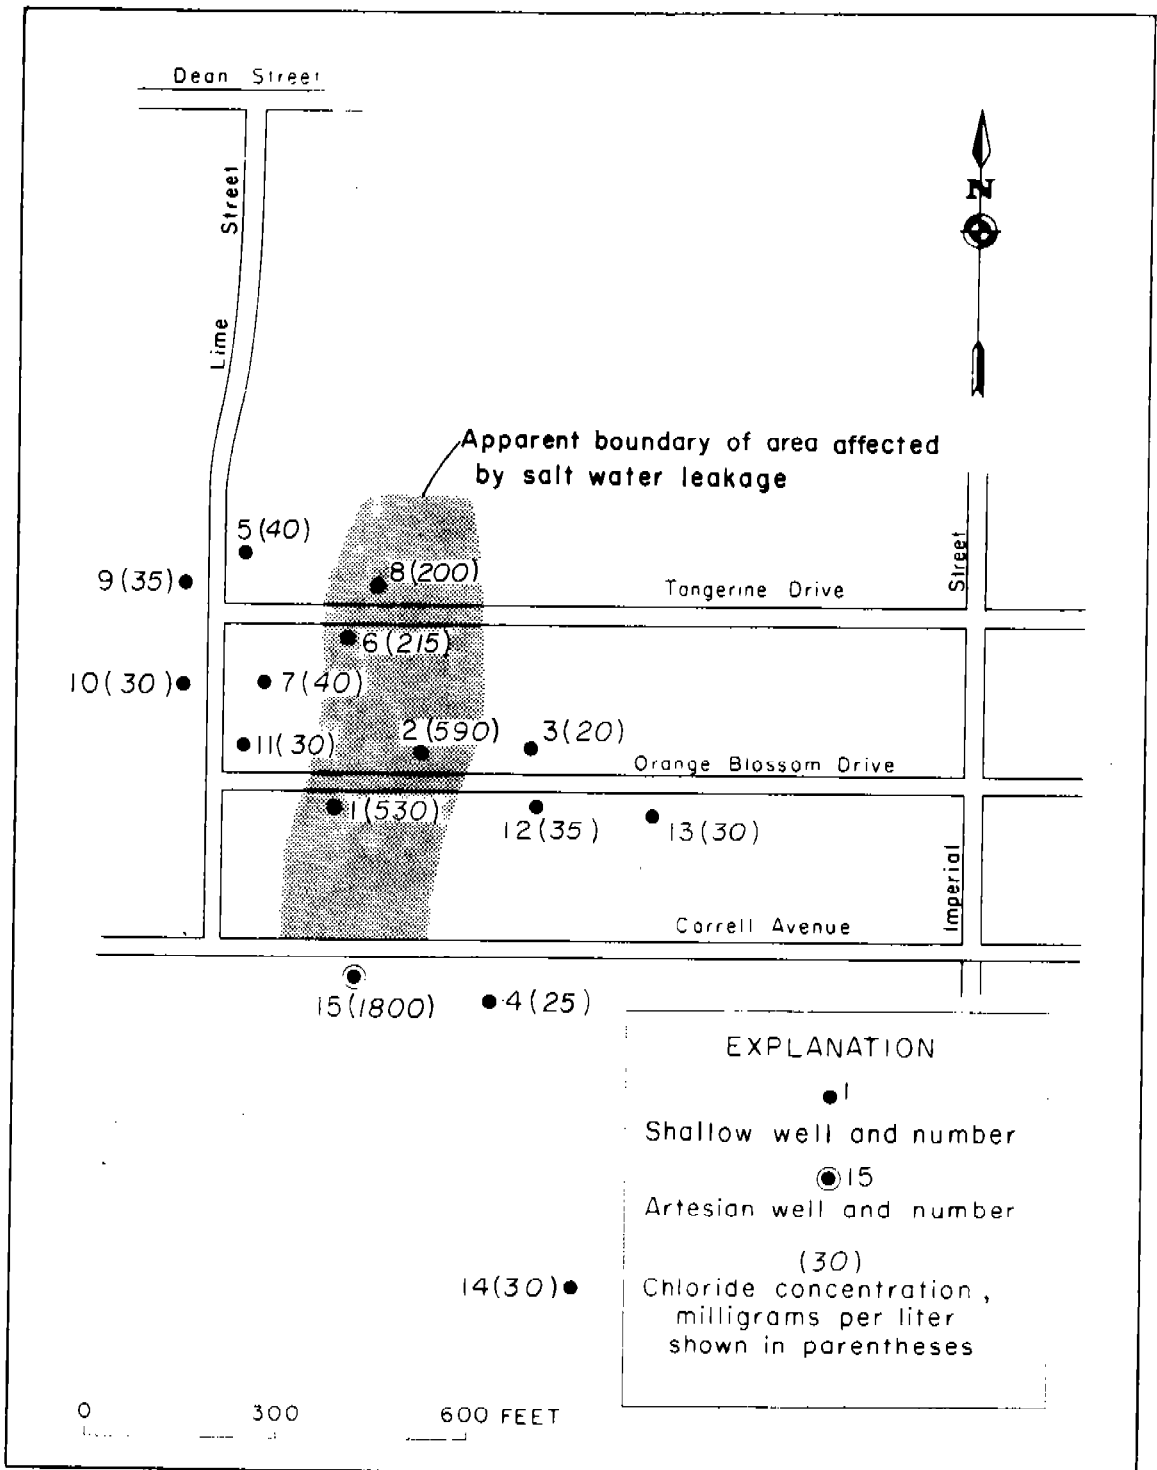
Figure 3.--Map showing location of wells at Highland Estates and chloride concentrations in water on January 24, 1968.

Figure 3 shows the location of 15 wells in the Estates and the chloride content in water samples collected from them on January 28, 1968. Except the samples from well 15, all were from wells 20 to 25 feet deep constructed in the water-table aquifer. As shown on figure 3, chloride concentrations in water from the shallow wells ranged from 25 mg/l in well 4 to 590 mg/l in well 2. Four shallow wells, numbers 1, 2, 6, and 8, alined northward, yielded water much higher in chloride than from similar wells in adjacent areas.

Well 15, south of well 1 and along the same general alignment (fig. 3), contained water with a chloride concentration of 1,800 mg/l. This well apparently tapped the lower Hawthorn aquifer at depths below 485 feet as evidenced by the high artesian head, 19.4 feet above land surface. The depth of the well could not be determined because of blockage within the well bore. Geophysical logs run on the upper part of the well indicated that the casing extended to a depth of only 80 feet.

The metal casing of well 15 was badly corroded particularly where the casing was leaking. The control valve on top of the casing, installed in 1961 to prevent flow from the well, was closed. The ground around the well was wet, although no standing water was evident. Upon opening the control valve, the well flowed about 5 gpm.

Based on the information obtained during the preliminary investigation, it was generally concluded that well 15 was the most likely conduit through which the saline water was entering the water-table aquifer near the four water-table wells at Highland Estates. This conclusion however, does not preclude the possible existence of saline water in other zones than the lower part of the Hawthorn.

The unusual distribution of higher chloride concentrations in wells 1, 2, 6, and 8 along the relatively narrow path north of well 15, probably resulted from local variations in the permeability of the sediments comprising the water-table aquifer. Most likely the path of intruding saline water marks the direction of the hydraulic gradient and the subsurface location of an accumulation of shell detritus or other material of high permeability that is similar to beds formed by wind and wave action along present shore lines.

On February 15, 1968, well 15 was plugged under the supervision of H.J. Woodard and C.R. Sproul of the Florida Department of Natural Resources. A water-cement mixture containing about 16 bags of cement was pumped into the well during the plugging operation. This stopped all visible leakage from the well at or near the surface and no further leakage has been noted.

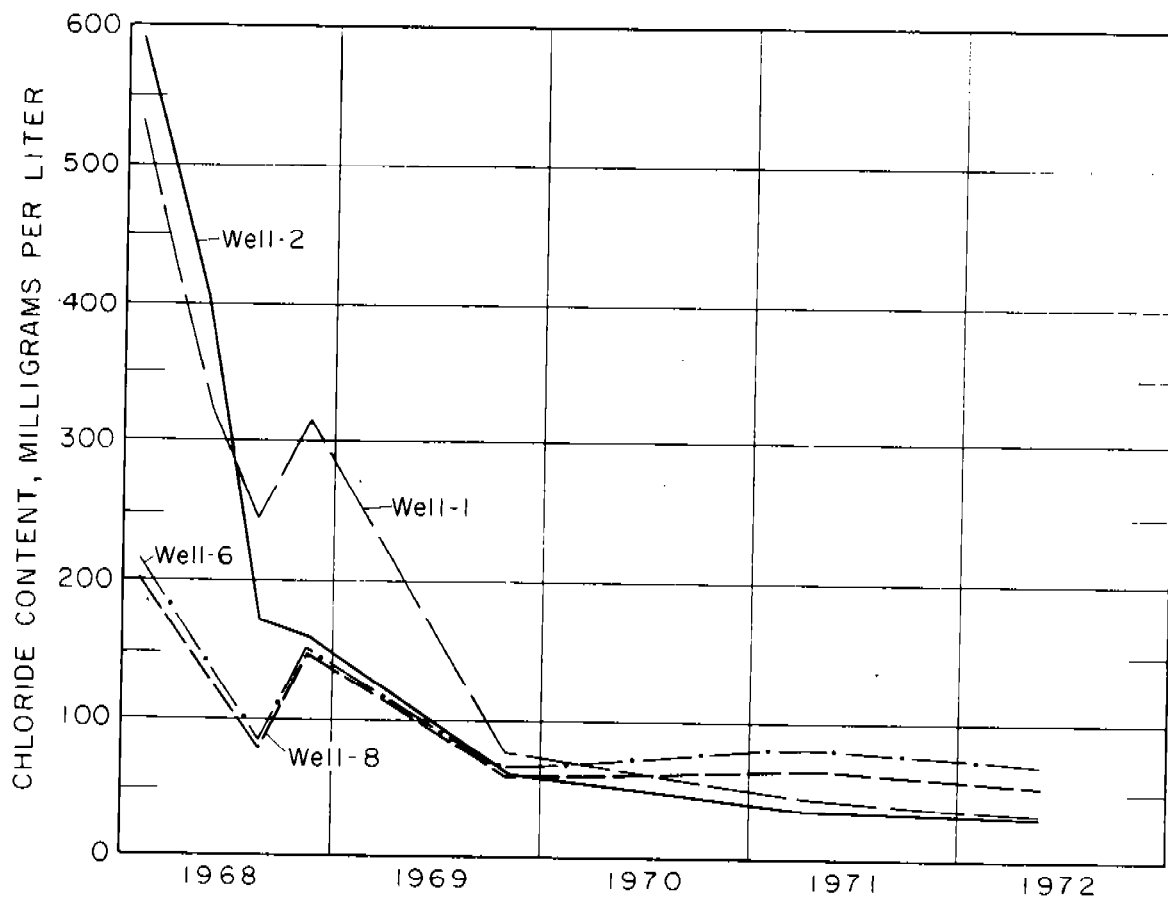
Figure 4.--Variations in chloride concentrations in wells 1, 2, 6, and 8, 1968-72.

After well 15 was plugged, the chloride content of water from wells 1 and 2, about 270 and 370 feet from well 15, decreased 180-200 mg/l by May 1968 as shown in figure 4. The chloride content continued to decrease until August when the total reduction was 285 mg/l in well 1 and 420 mg/l in well 2. The chloride content of water from wells 6 and 8, about 540 and 620 feet from well 15, decreased 120-130 mg/l over the same period. The reduction in chloride concentrations probably was related in part to the dilution and flushing of saline water from the aquifer by rainfall which began in May.

Analyses made in November 1968, after this initial period of decreasing concentrations, indicated that chloride in water from wells 1, 6, and 8 had increased by 65-70 mg/l. This probably represents residual contamination from saline water that had gained access to the aquifer before well 15 was plugged.

By October 1969, about 20 months after well 15 was plugged, the chloride content of water from wells 1, 2, 6, 8 was less than 80 mg/l, indicating a decrease of 452 mg/l in well 1; 528 mg/l in well 2; 151 mg/l in well 6; and 140 mg/l in well 8. Additional observations in April 1971 and May 1972 indicated some variation in chloride content in wells 6 and 8, but a continued decrease in wells 1 and 2.

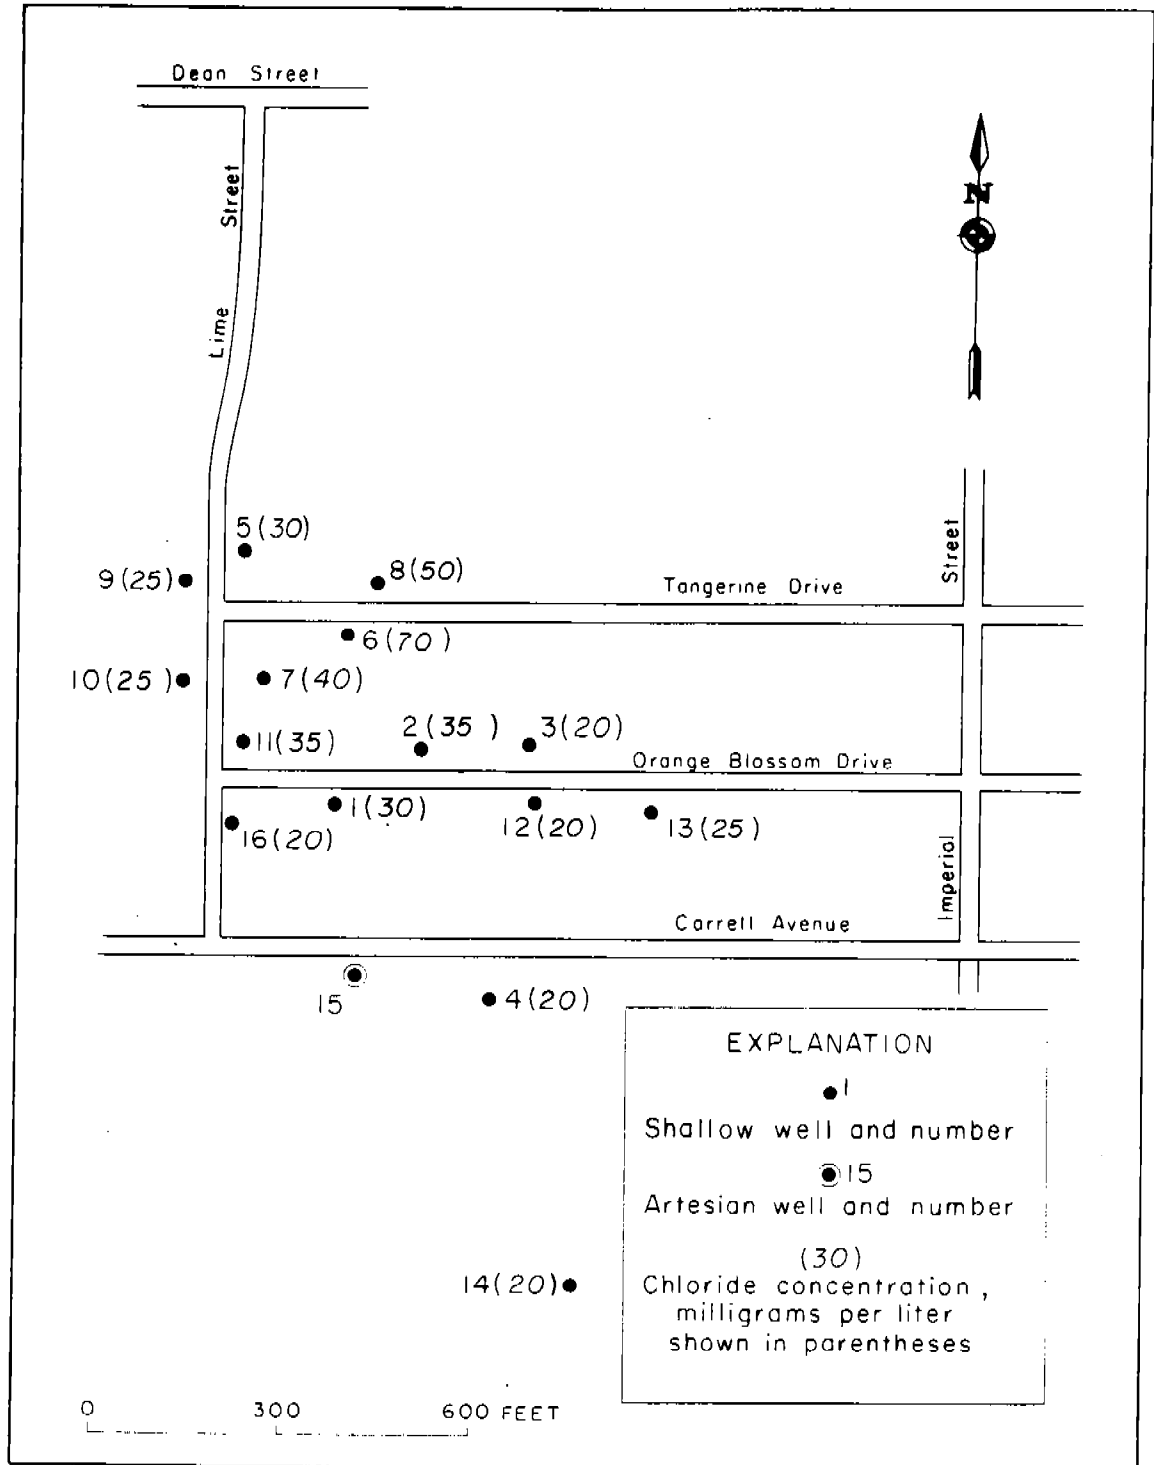
Figure 5.--Map showing chloride concentrations in wells at Highland Estates on May 24, 1972.

All except one of the wells sampled in January 1968 were sampled again in May 1972, more than 4 years after plugging well 15. The chloride analyses are shown in figure 5. Water from wells 1 and 2, formerly most affected by leakage of saline water from well 15, contain chloride within the normal range in water from other wells in the water-table aquifer. Wells 6 and 8 showed some residual effects of the saline water which entered the aquifer earlier.

The results of this brief investigation provides reliable evidence that surface discharge and subsurface leakage from well 15 were the primary sources through which saline water entered the water-table aquifer at Highland Estates. The results further indicate that rainfall will, in time, dissipate most of the effects of the saline water, provided the conduit remains tightly sealed.
