**HYDROLOGIC EFFECTS OF STORM OF  
SEPTEMBER 1-3, 1983 IN  
GOLDEN GATE CITY  
COLLIER COUNTY, FLORIDA**

Prepared For  
**BIG CYPRESS BASIN BOARD  
SOUTH FLORIDA WATER MANAGEMENT DISTRICT**

Prepared By  
**JOHNSON ENGINEERING, INC.**  
Civil Engineers & Land Surveyors  
Fort Myers, Florida

September, 1983

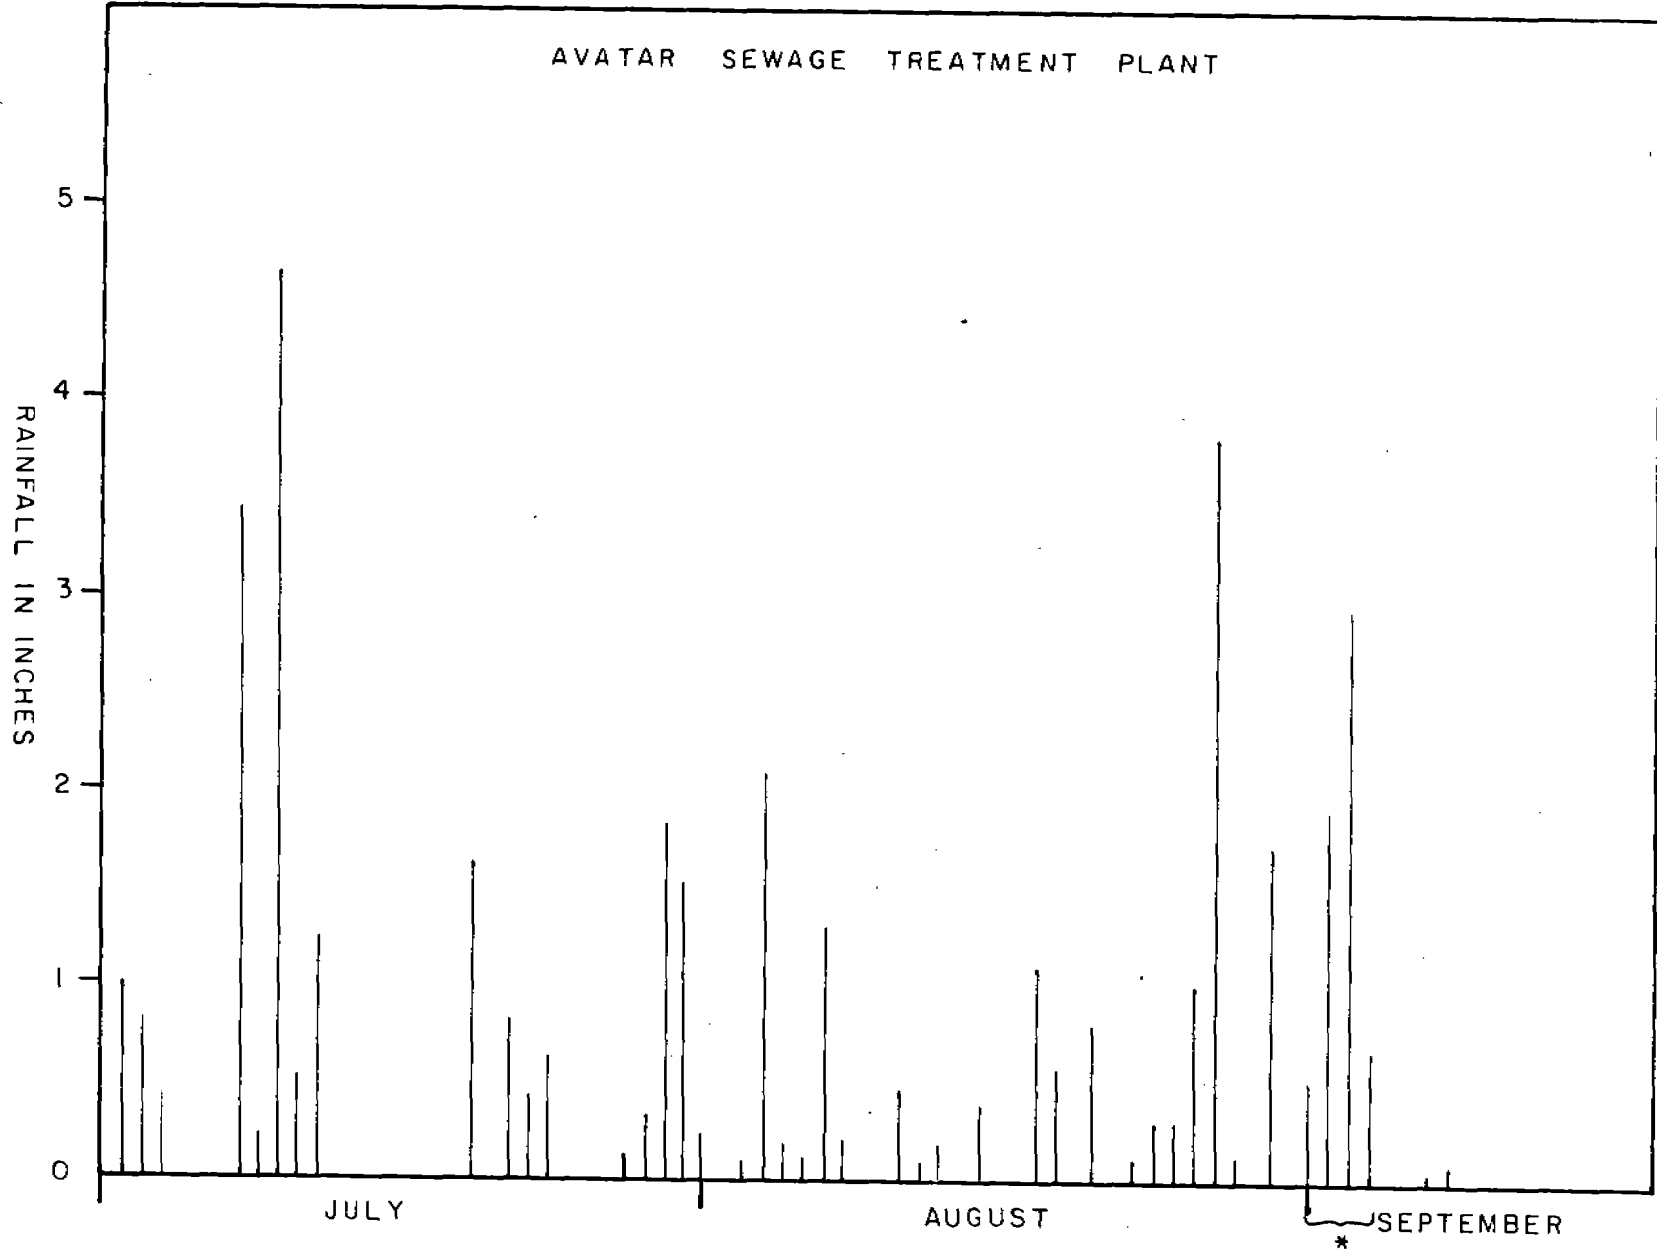
FIGURE 2

\* RAINFALL SHOWN FOR AUGUST 31 THROUGH SEPTEMBER 3 IS AN AVERAGE OF 7 LOCALIZED COLLIER CO. RAINFALL STATIONS

DAILY RAINFALL \*  
JOHNSON ENGINEERING, INC.  
SEPTEMBER 1984

Rainfall data collected prior to and including September 1-3, 1983 is given in Table 1 on page 3-3 and the location of gaging stations is shown on page 3-2. The figure on page 3-4 shows the average rainfall for the period from the first of July through mid September.

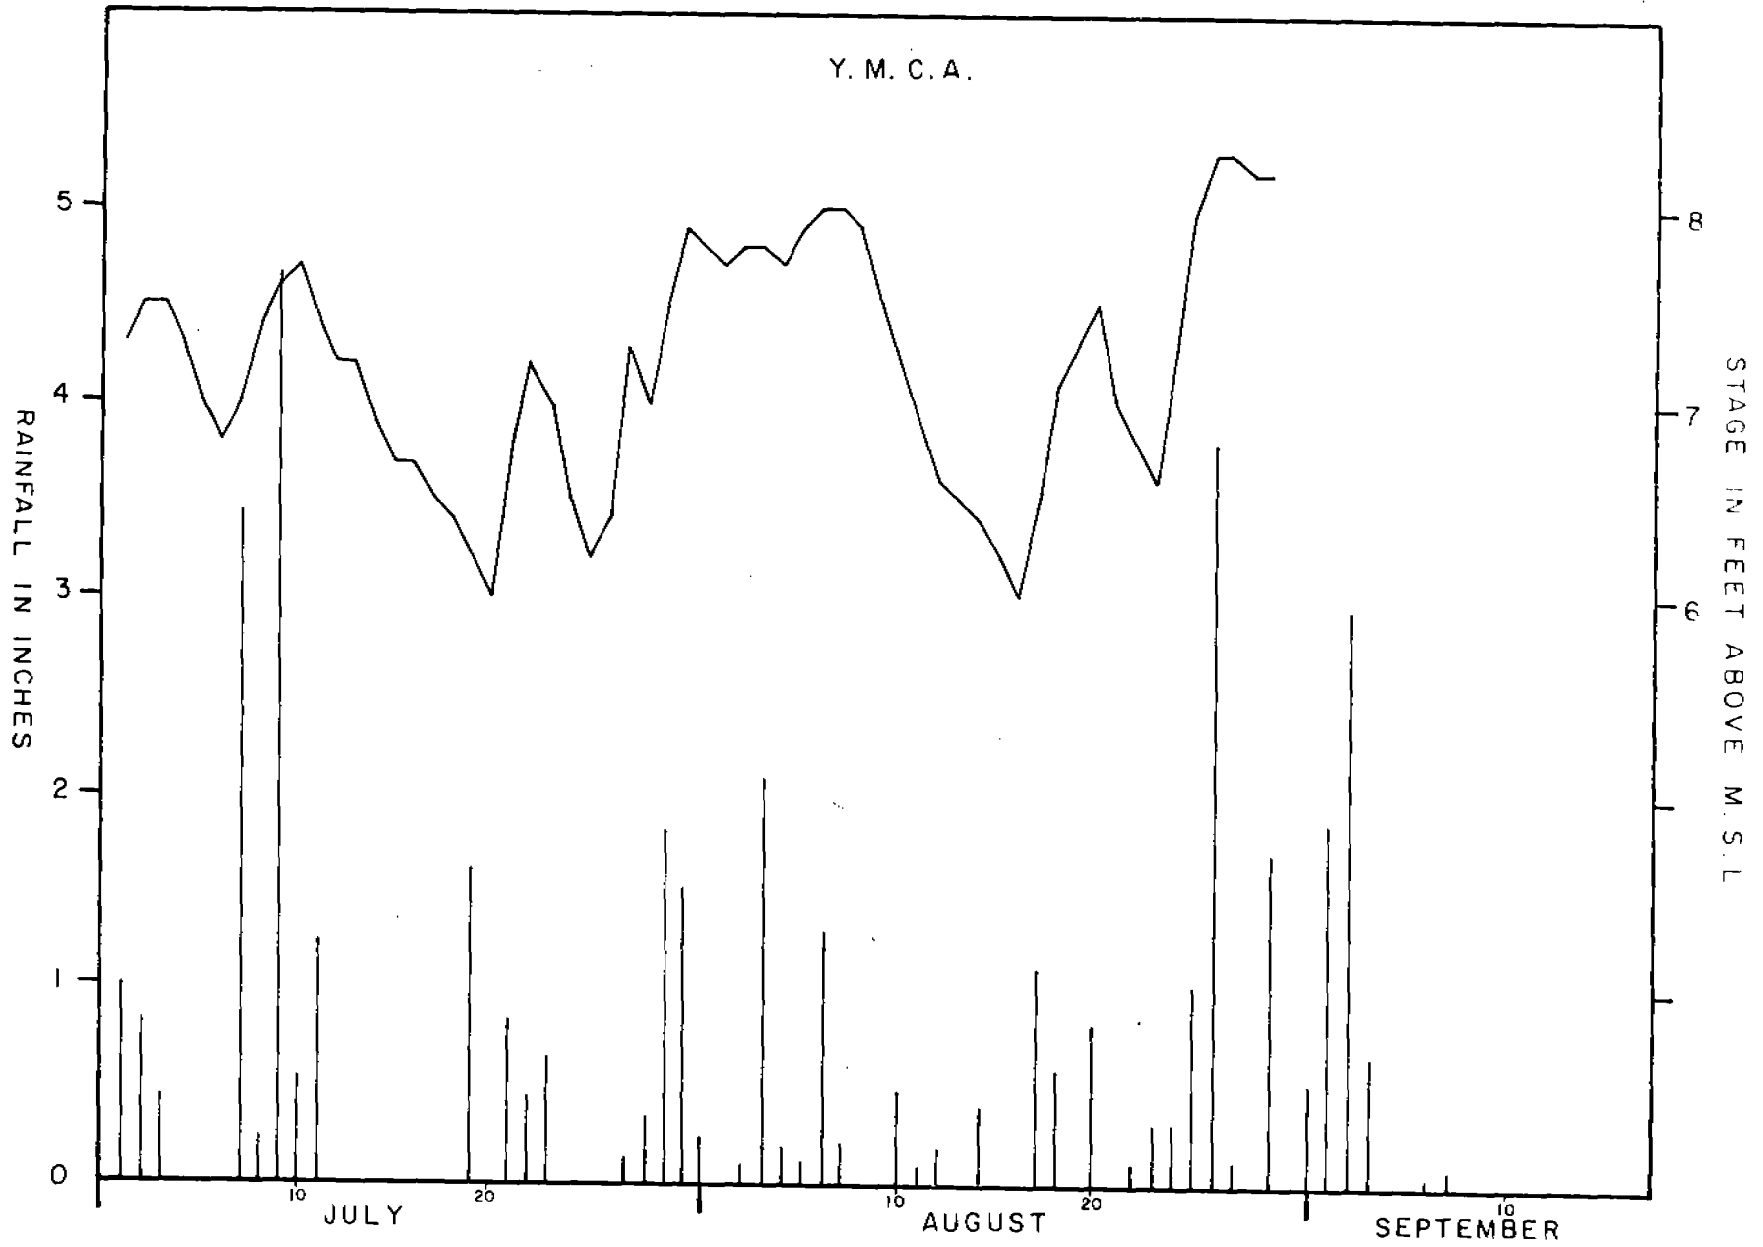
4 - 2  
FIGURE 4

The groundwater table elevation for the two locations shown on page 3-2 were supplied by Big Cypress Basin. Records show a typical lagging of rise in the groundwater following a rainfall event. Figures on pages 4-2 and 4-3 show the recorded elevations with an overlay of the rainfall data (shown previously on page 3-4). Although these groundwater recorders are outside Golden Gate City, they indicate how the earlier rainfall events affected the outcome of following storms. This was evidenced by the rainfall of September 1-2, 1983 following the rainfall of August 25-26, 1983.

GROUND WATER LEVELS AND DAILY RAINFALL  
JOHNSON ENGINEERING, INC.  
SEPTEMBER, 1983

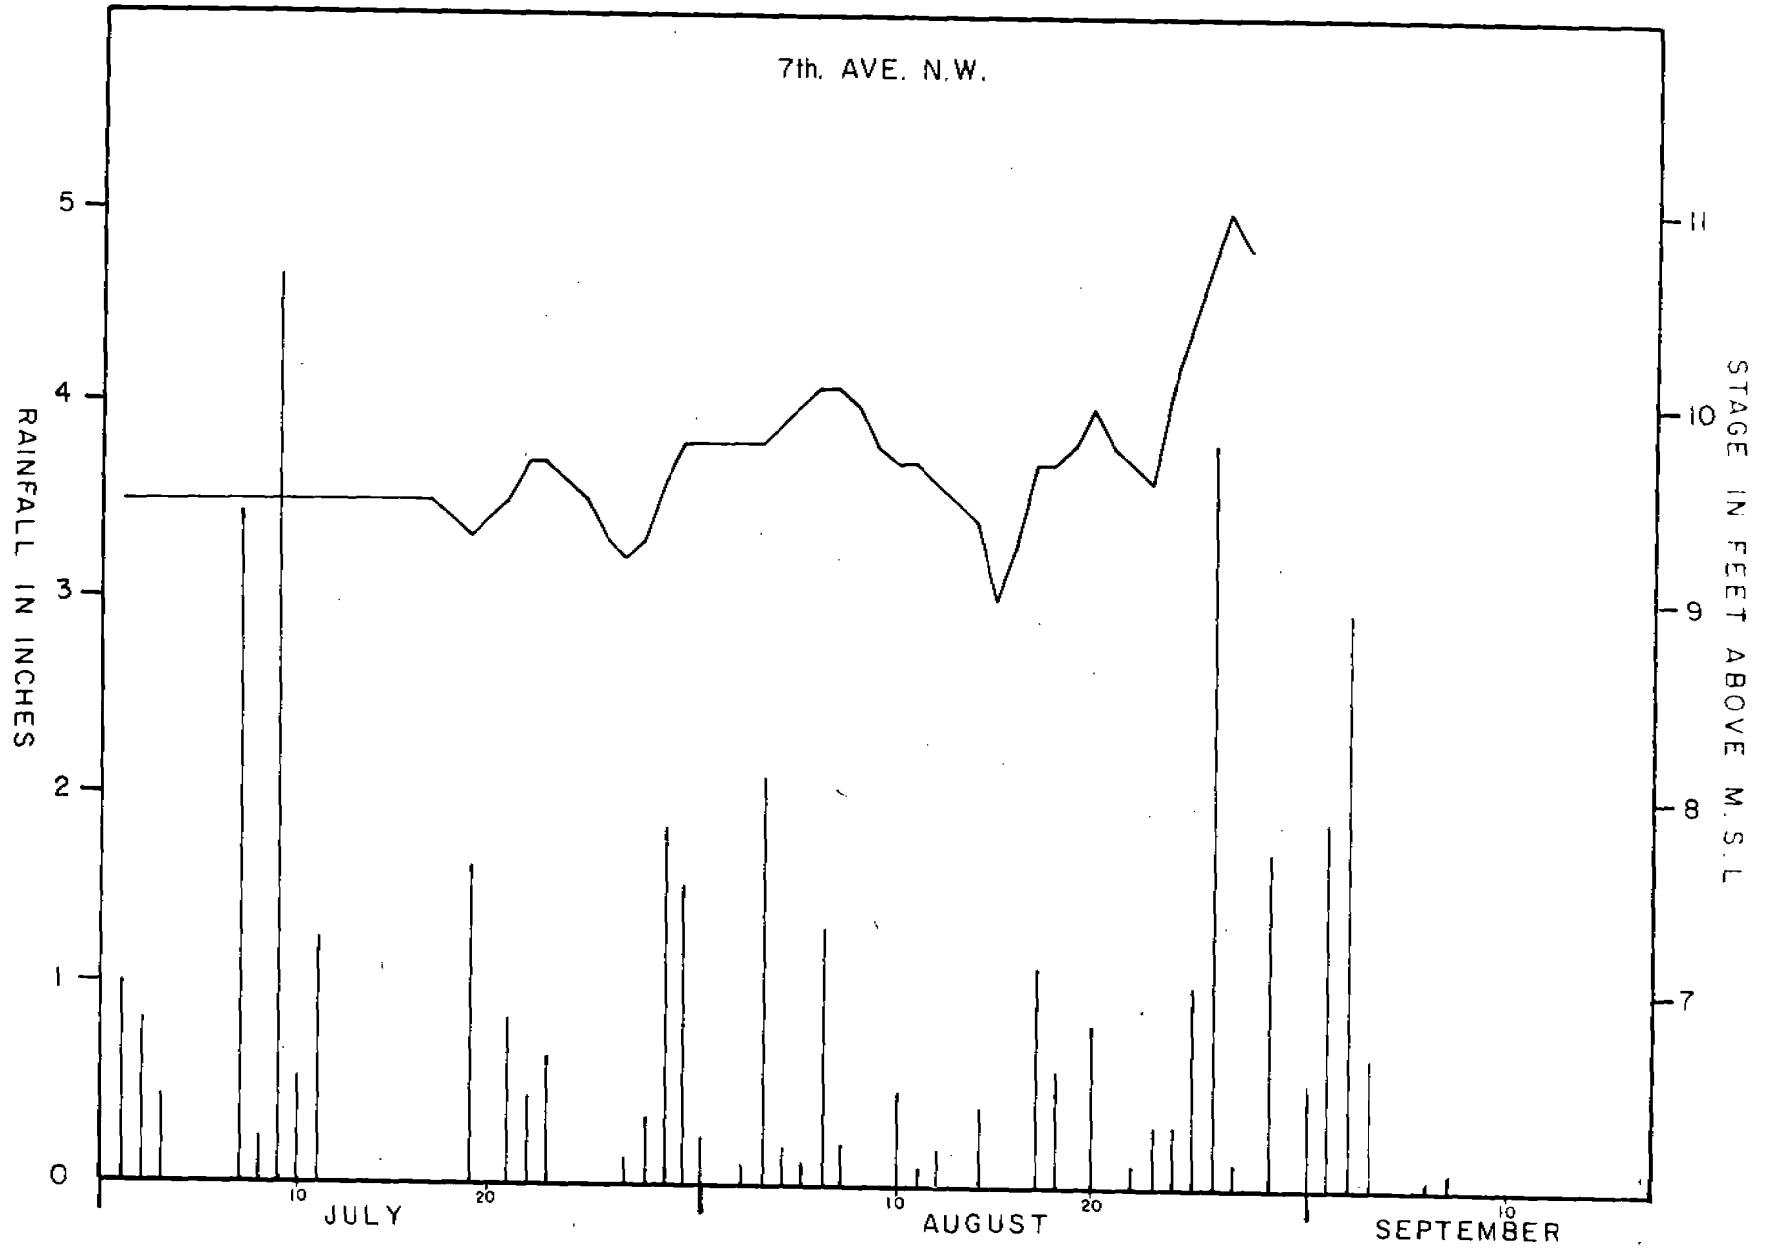
FIGURE 4

GROUND WATER LEVELS AND DAILY RAINFALL  
JOHNSON ENGINEERING, INC.  
SEPTEMBER, 1983

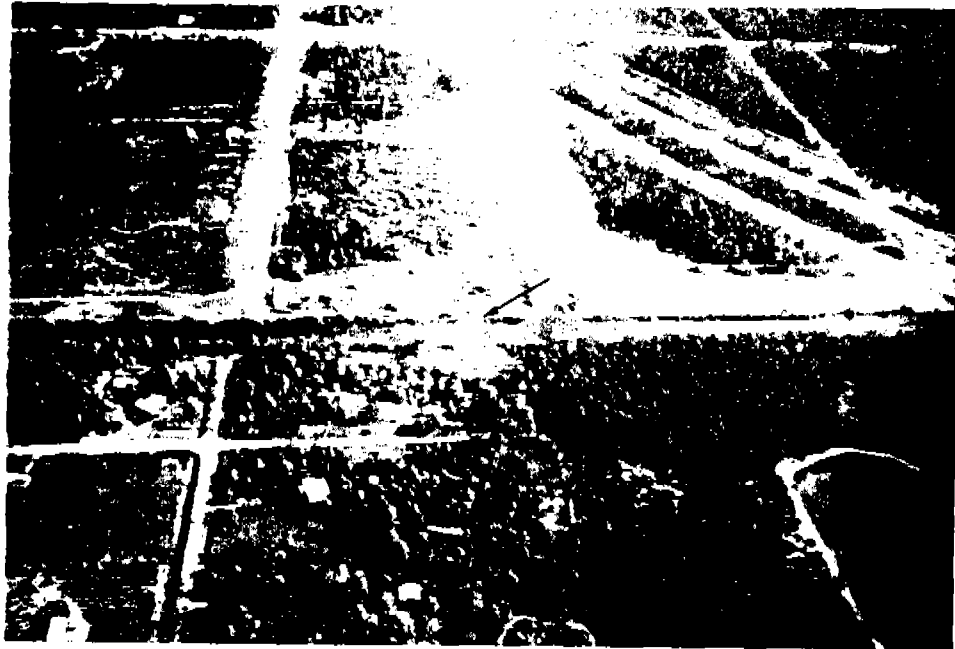
Look north at Golden Gate Weir No. 2 (at arrow).  
I-75 is at top right.

With the exception of the 150 cfs entering the canal at Airport Road there is very little change in the canal discharge upstream until the intersection of the D-2 (Oaks Blvd.) Canal is reached. Using the upstream and downstream water surface elevations and a correction factor for discharge over a submerged weir, the flow at Golden Gate #2 weir was calculated to be 1,430 cfs.

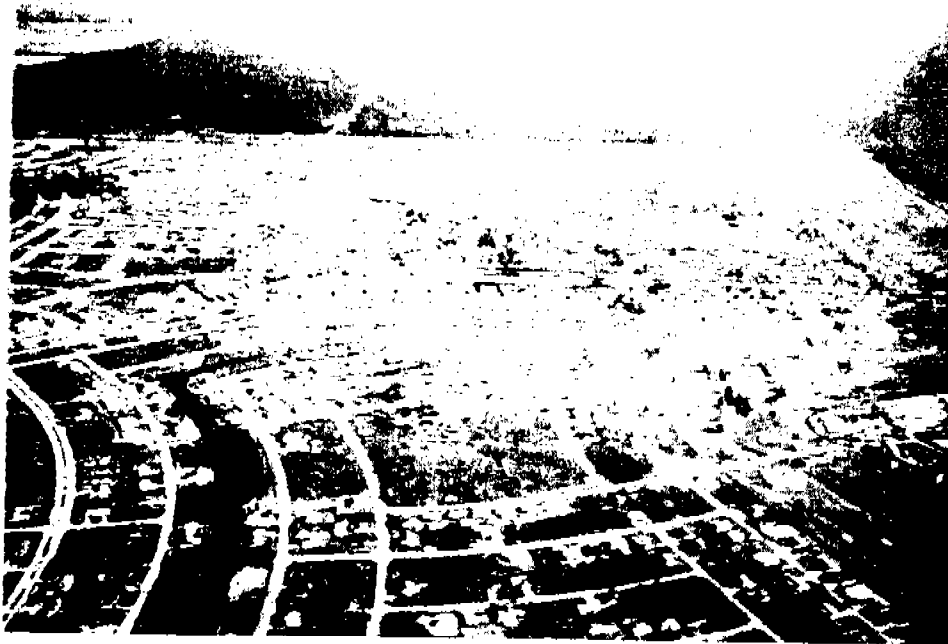
Look north at Golden Gate City.  
Golden Gate Parkway is denoted by dots.  
Note area south of Parkway is not subject to flooding.

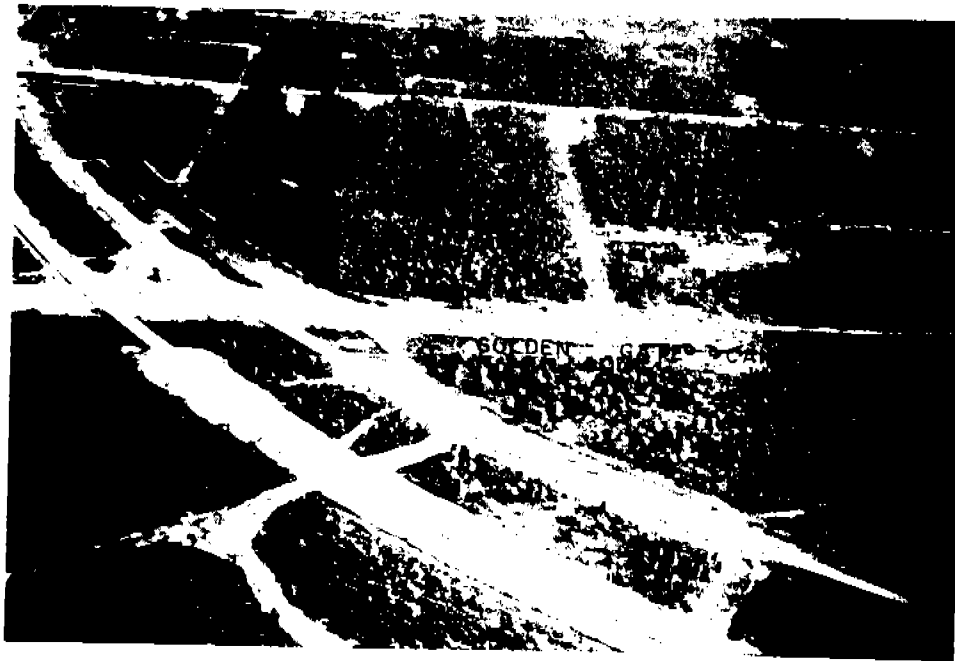
Look north with the repositioned D-2 (Oaks) Canal  
in the upper left corner.

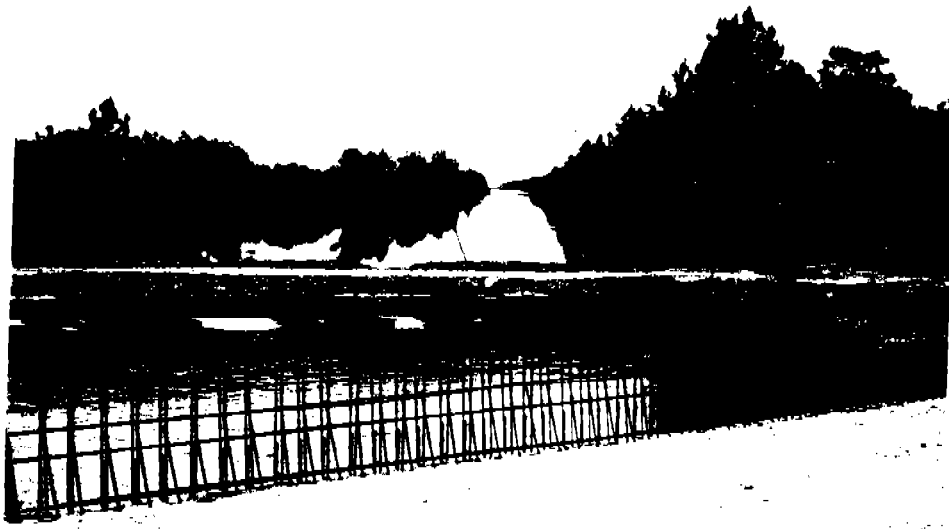
Look east up Golden Gate Canal at temporary crossing.  
Photo taken from permanent I-75 bridge crossing  
(reinforcing steel for guardrail is in foreground of photo).

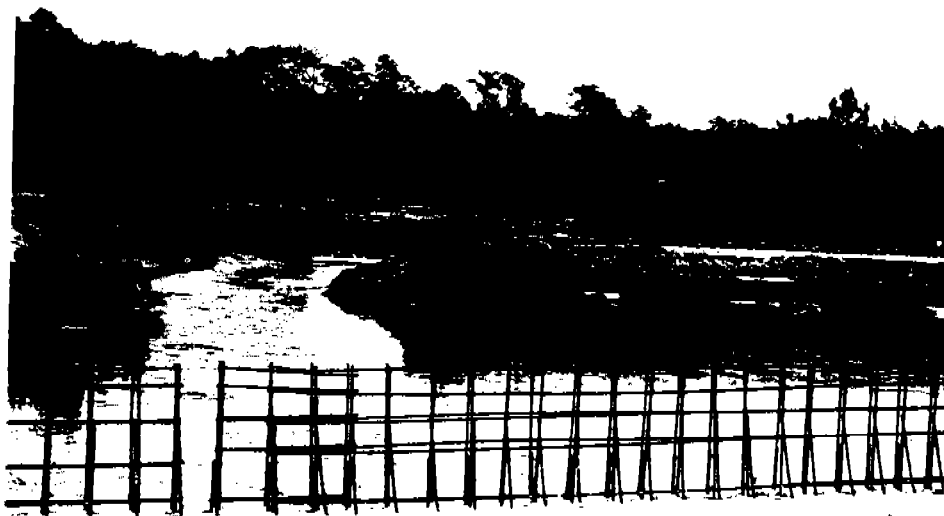
Photo taken from same location as above.  
Look northeast at emergency bypass channel.

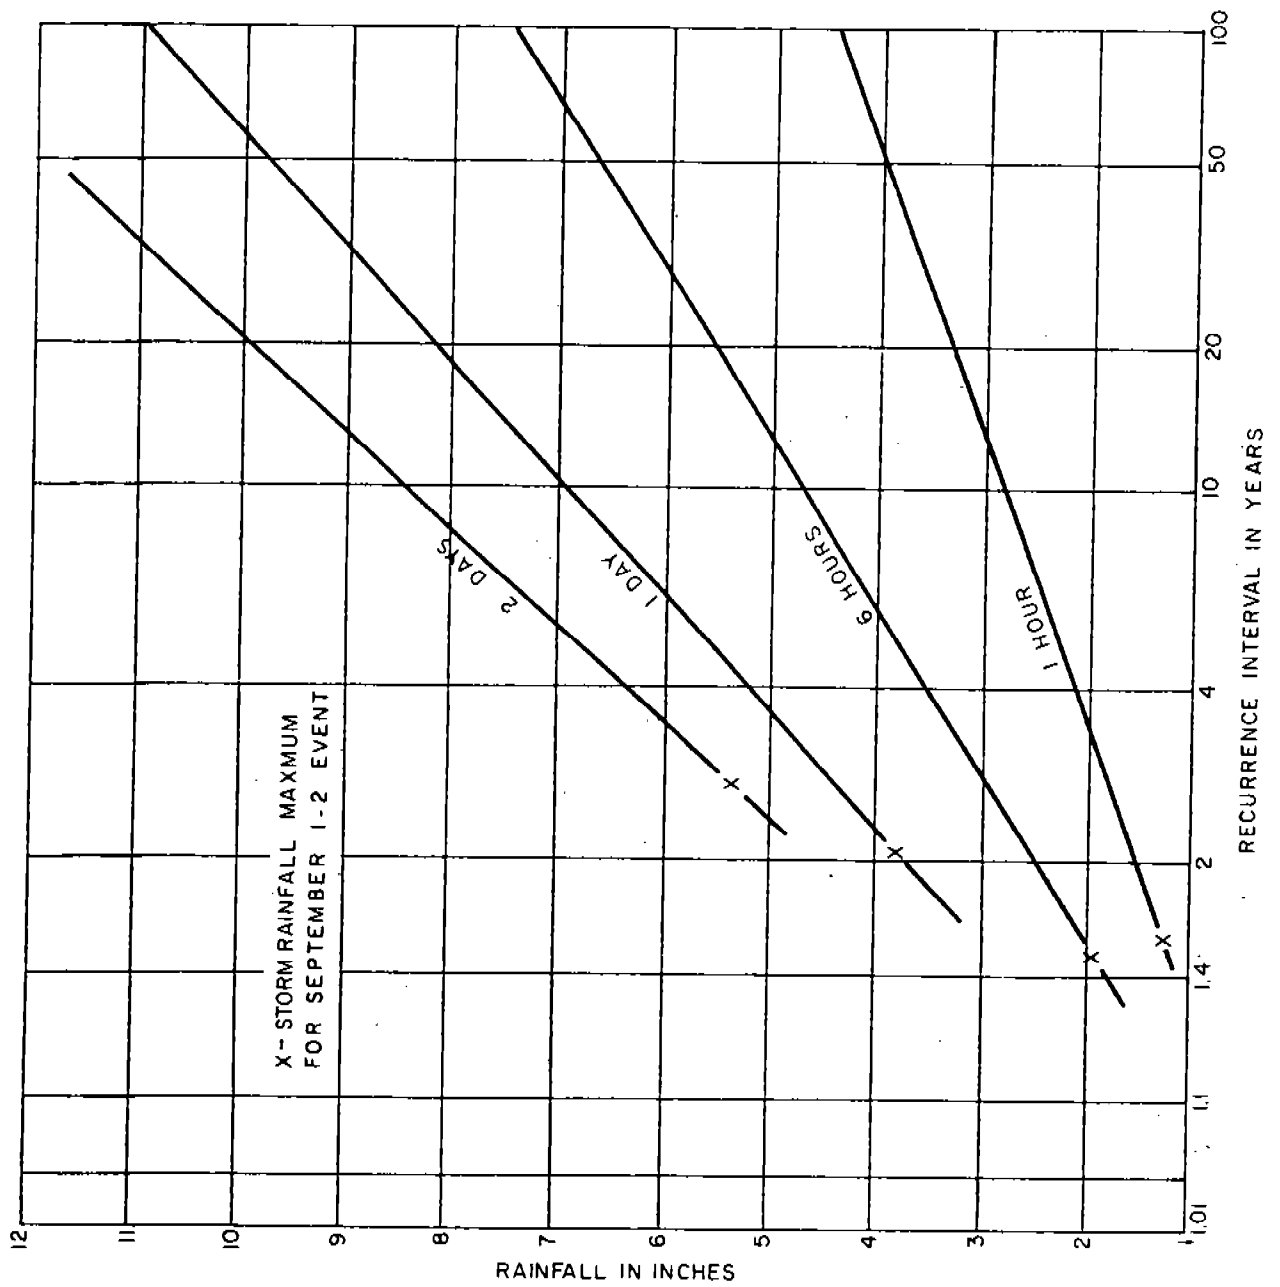
FIGURE 7. - RAINFALL DEPTH-FREQUENCY-DURATION CURVES FOR AREA OF GOLDEN GATE CITY.

The above rainfall data was plotted on the depth-duration-frequency curves on page 6-3. These curves were derived from the values in Table 3 on page 6-6 and based on rainfall distribution given in the South Florida Water Management District Manual IV.

The maximum one-hour rainfall recorded at the Courthouse only slightly exceeded an annual occurrence. The six-hour amount was less than a two-year event. The one and two-day rainfalls were slightly rarer than the one and six hour events but nothing exceeding the three-year event. This rainfall followed one week after a similar rainfall event from the fringes of tropical storm Barry.

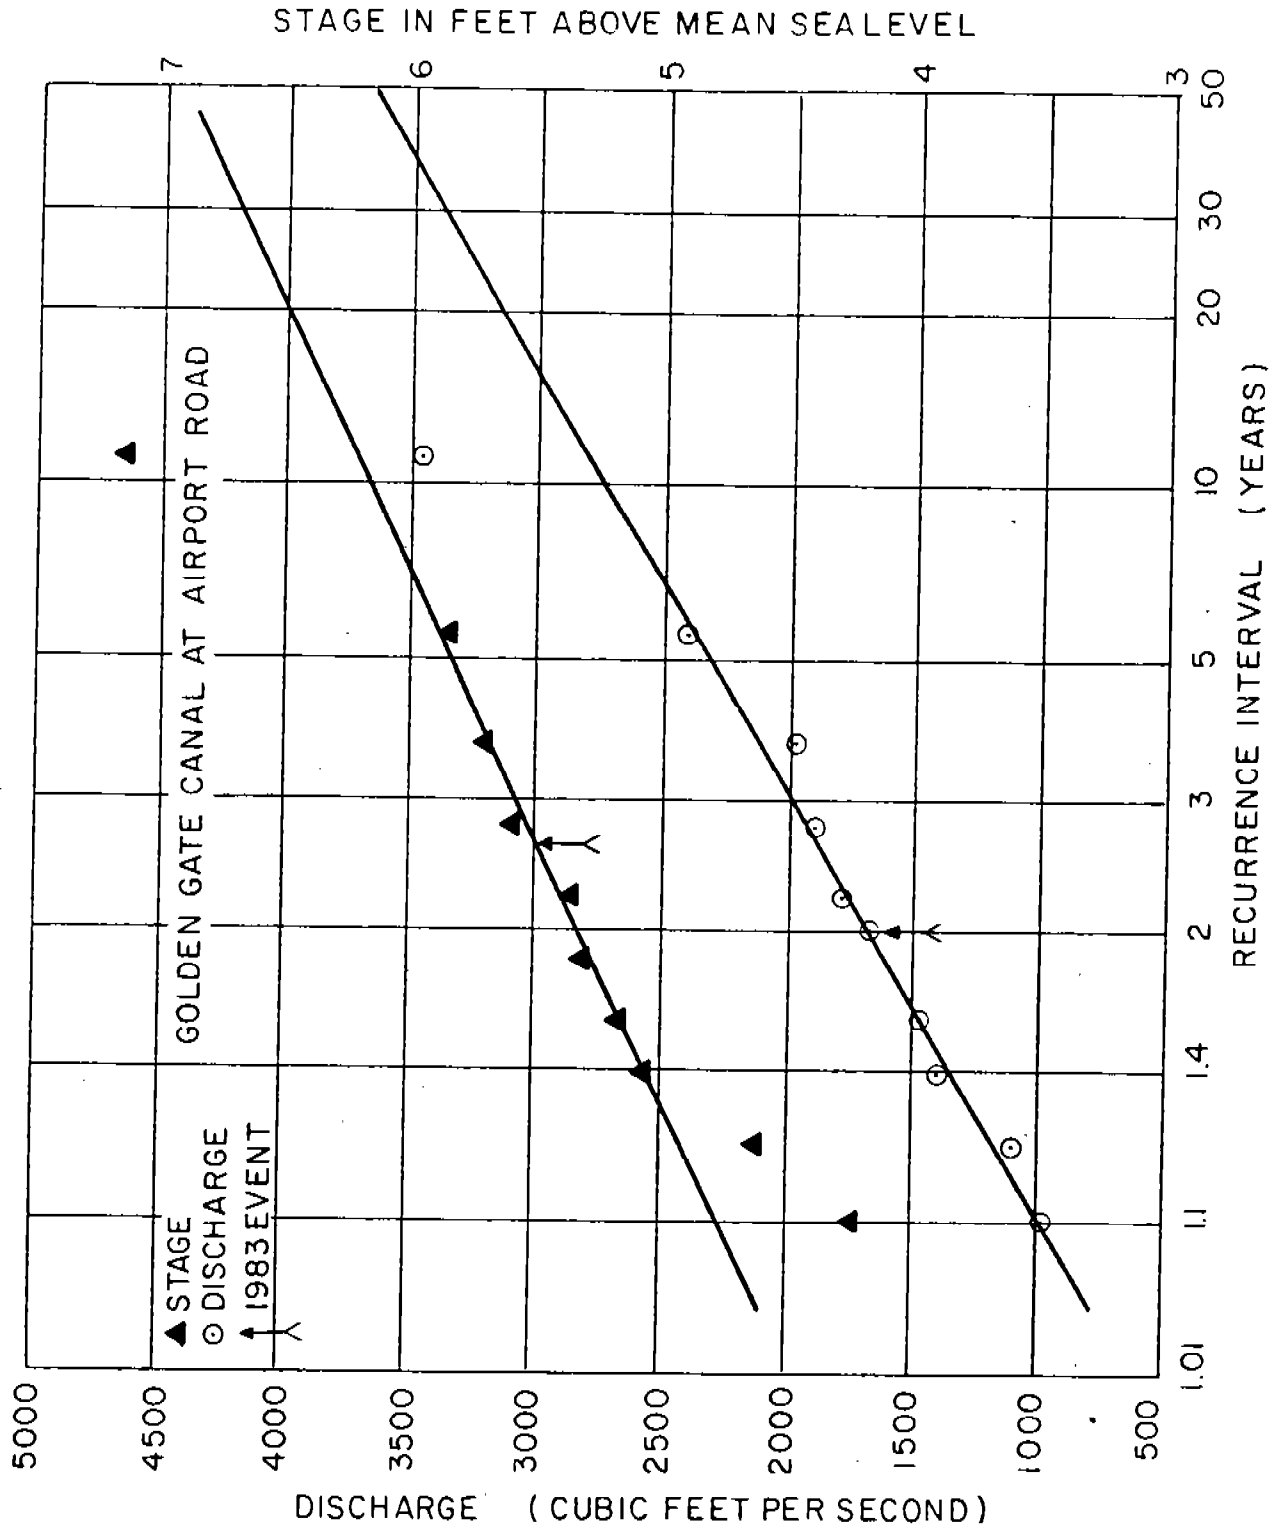
FIGURE 8

The measured flow of 1,680 cubic feet per second on September 4, 1983 is plotted on Figure 8 on page 6-5 taken from U.S. Geological Survey "Water-Resources Investigations 57-75" indicating a two-year recurrence interval. The stage was a similar event approximately equal to a three-year event.

DISCHARGE AND STAGE FREQUENCY CURVES

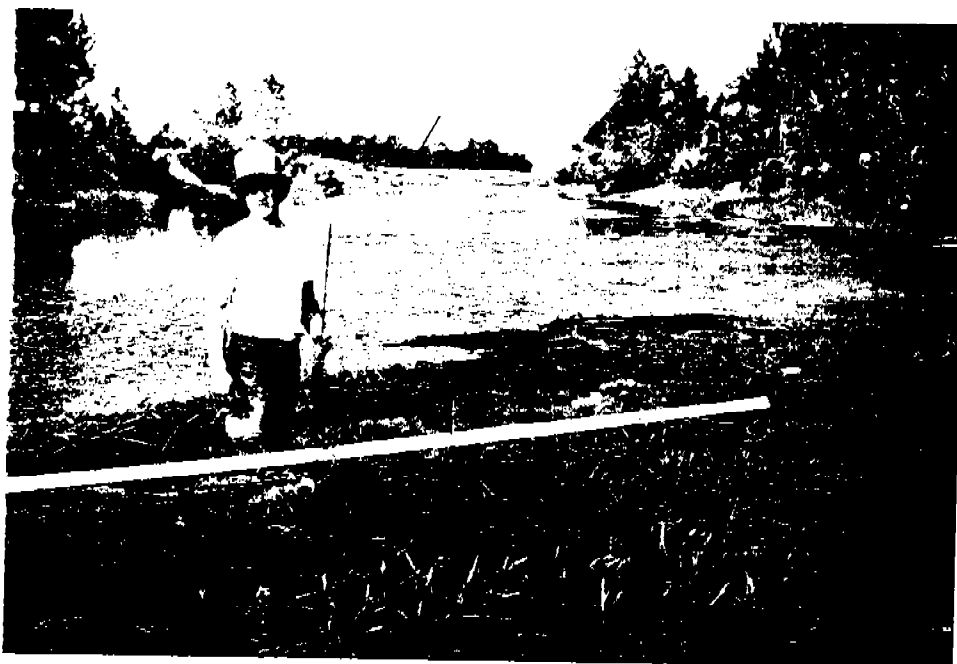
Blockage in Golden Gate Canal south of  
17th Avenue Weir - January 3, 1983.  
Stage recorder at arrow is same one shown in photos on page 6-10.

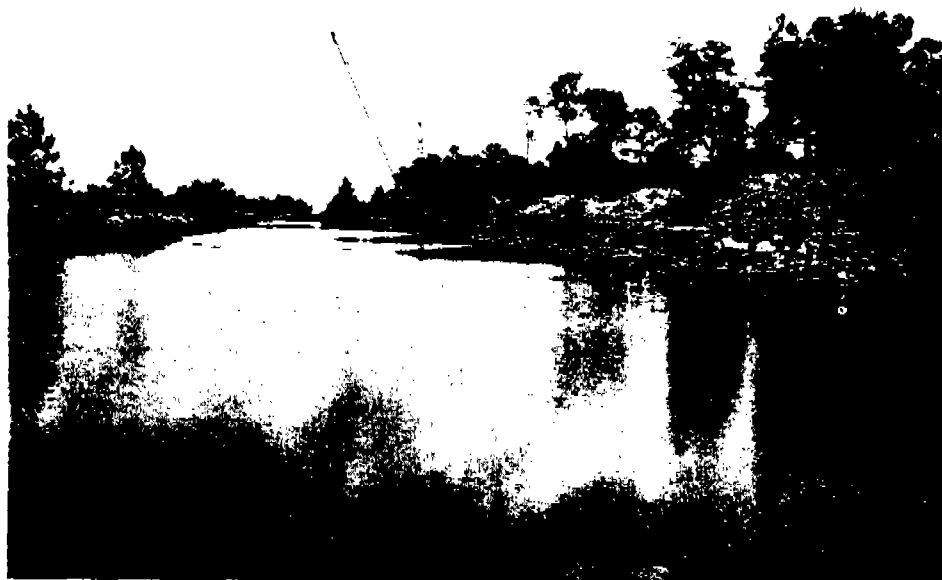
Look north up canal at excavation nearing completion.

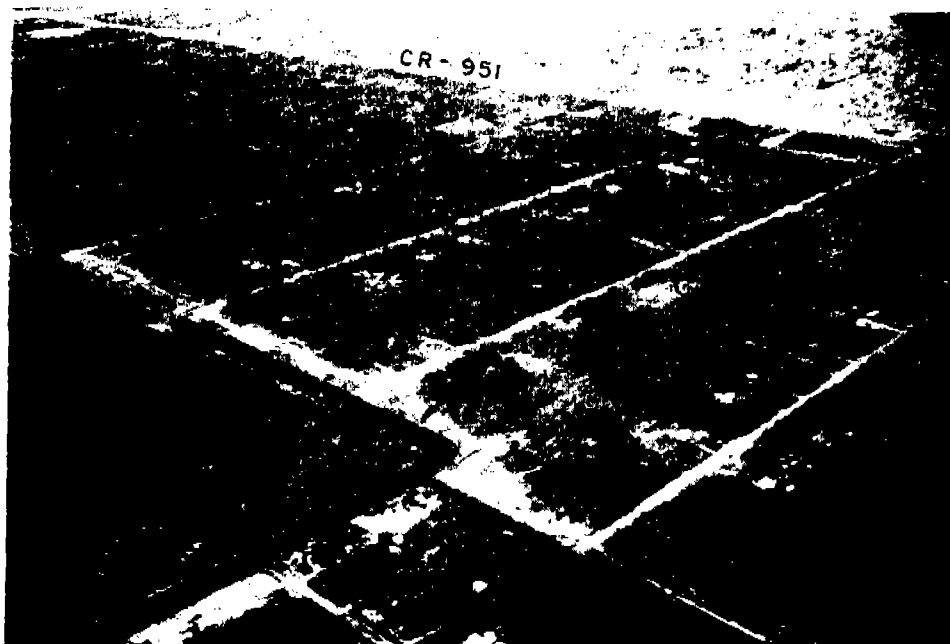
Look southwest across Golden Gate Canal - Sept. 3, 1983  
17th Avenue recorder is at arrow (see next page for ground  
shots of weir). Note well drained condition of roads in section  
of Golden Gate Estates east of CR-951. Golden Gate City is in  
background at upper right.

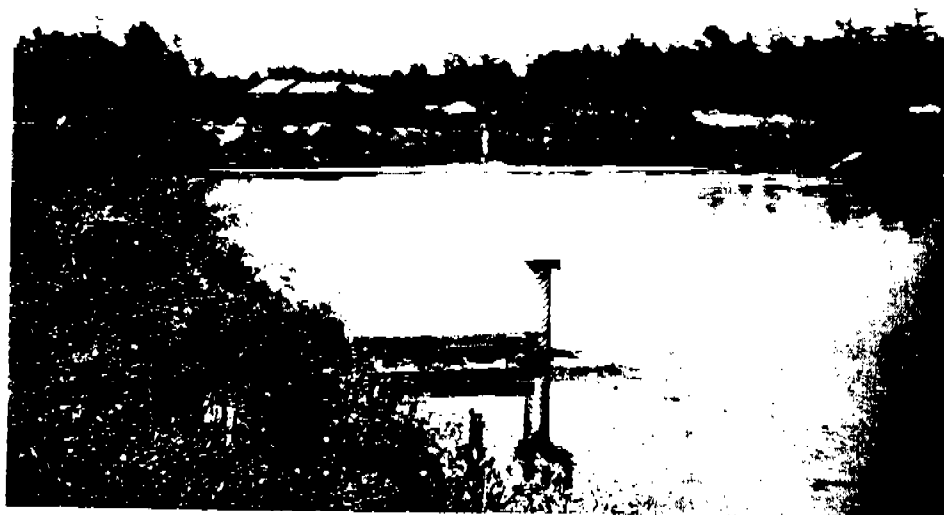
in 1981. This is conclusively illustrated by the photographs on page 6-10.

Same view as above -- September 4, 1983.  
Note decrease in water stage by comparing 1981 and 1983  
levels at nearest recorder (shown in both photos).

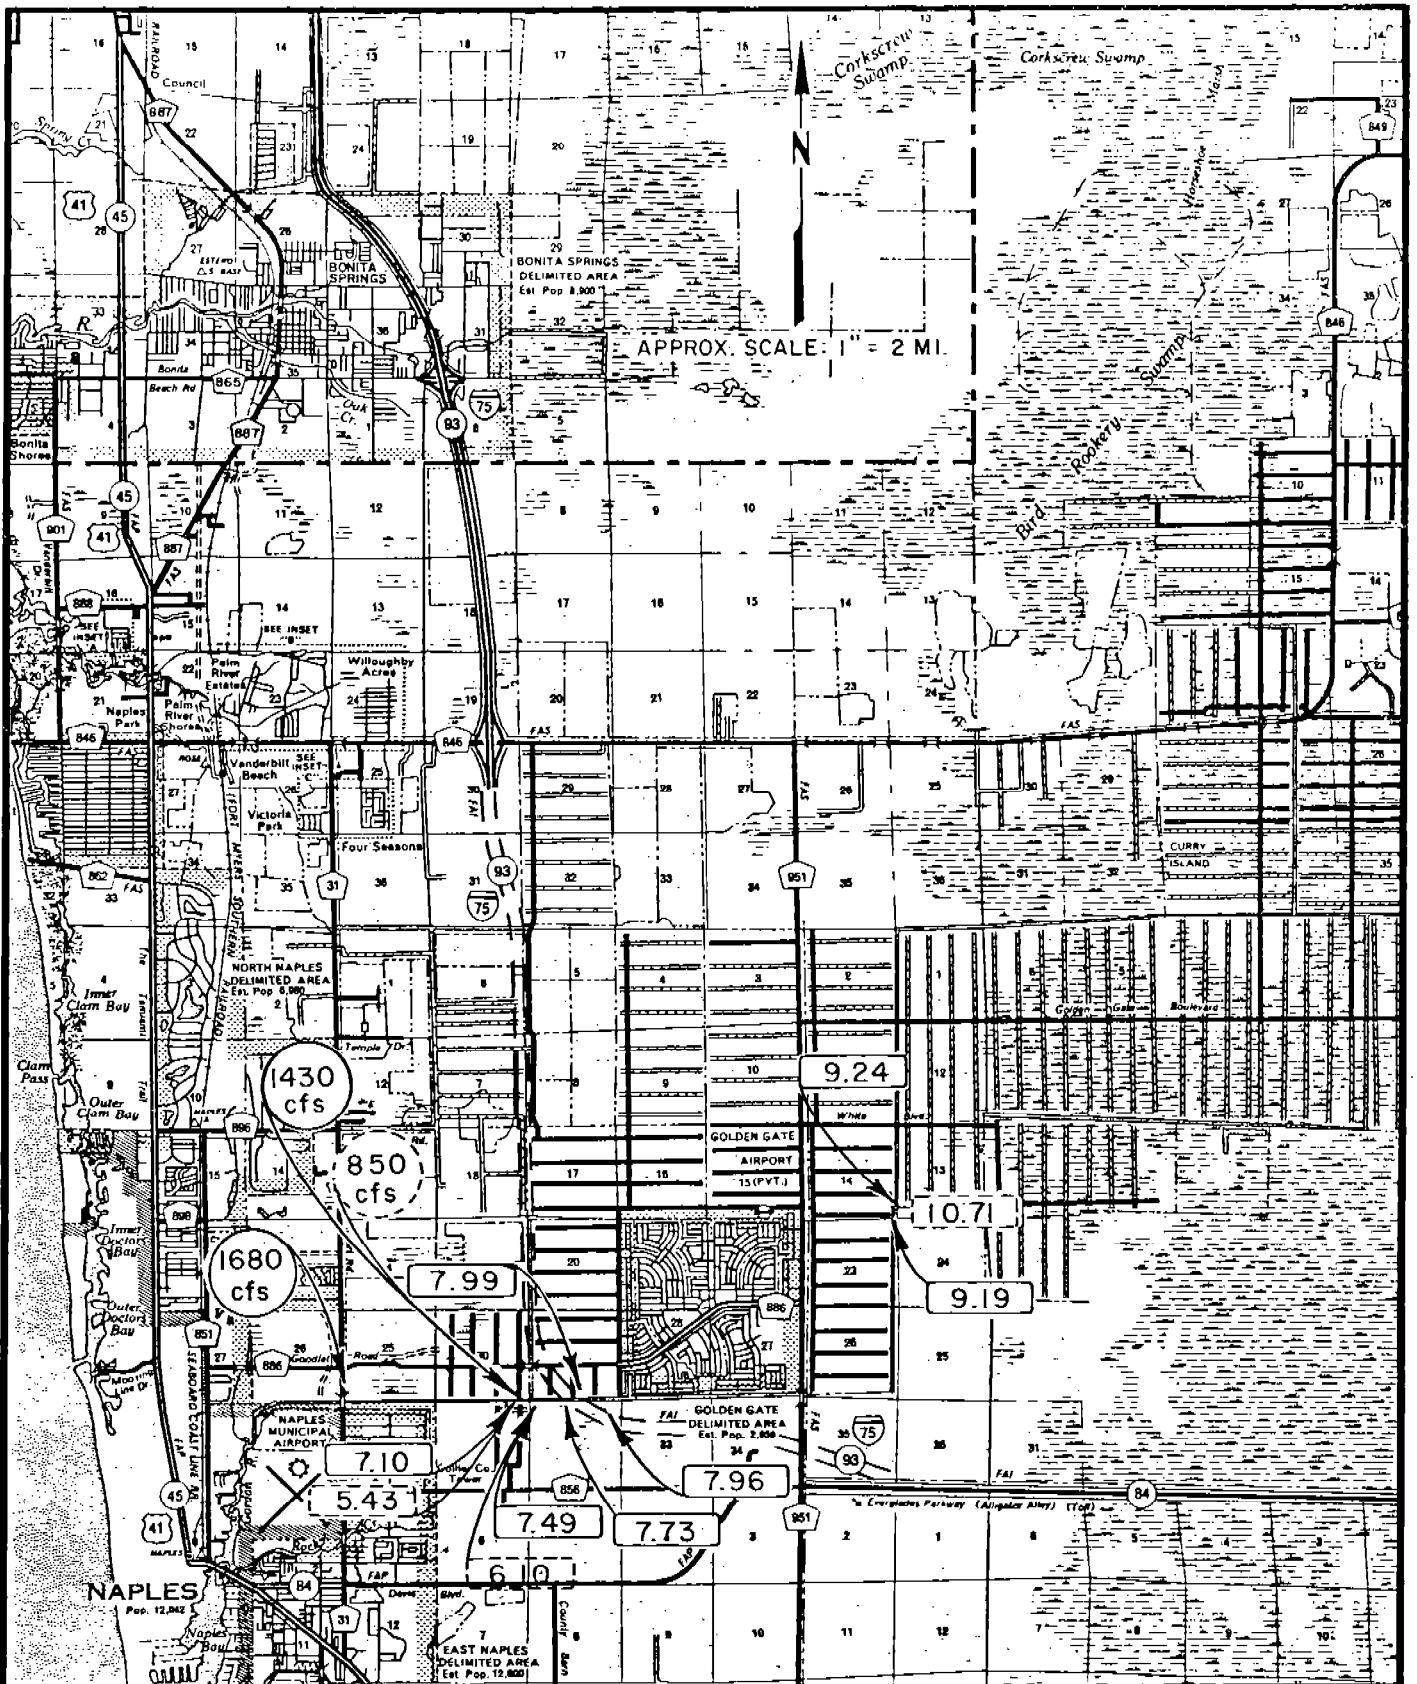
- 10.71 WSEL 8-26-81      cfs = CUBIC FEET PER SECOND
- 9.24 WSEL 9-4-83
- 1430  
cfs DISCHARGE 9-4-83
- 850  
cfs DISCHARGE 8-26-81

## WATER SURFACE ELEVATIONS

with the location shown in Appendix page A-9. The work was accomplished using a cable suspended "Price Current Meter". The velocity profile was checked to verify a near logarithmic shape near the center of the channel with the remainder of the vertical profiles measured only for the mean velocity. The flow was measured by summation of the product of the mean velocity and area of each channel cross section segment.
